Removal of Tree at 401 S. Garth

EXECUTIVE SUMMARY:

After being contacted by several concerned citizens, Water and Light has investigated removing a tree located at 401 South Garth. The tree is in current contact with telephone facilities and poses an immediate threat to them. The telephone facilities are attached to a pole that serves as a down guy for a Water and Light three phase line across the street. If the tree were to fall it would most likely cause an outage to over 1000 customers. Water and Light has collaborated with the City's Arborist who also recommends that the tree be removed. The tree would be replaced with an appropriate species through Water and Light's Trade-a-Tree program.

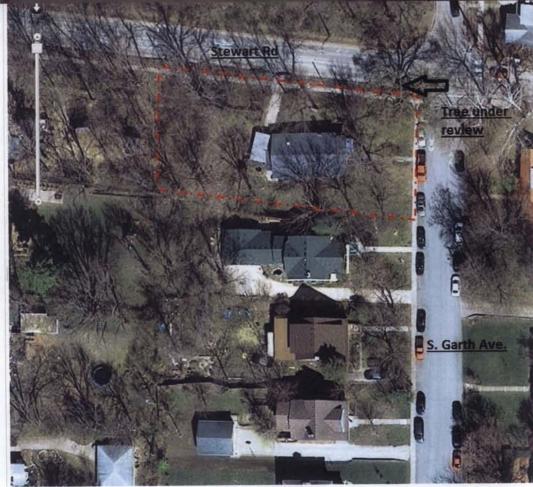
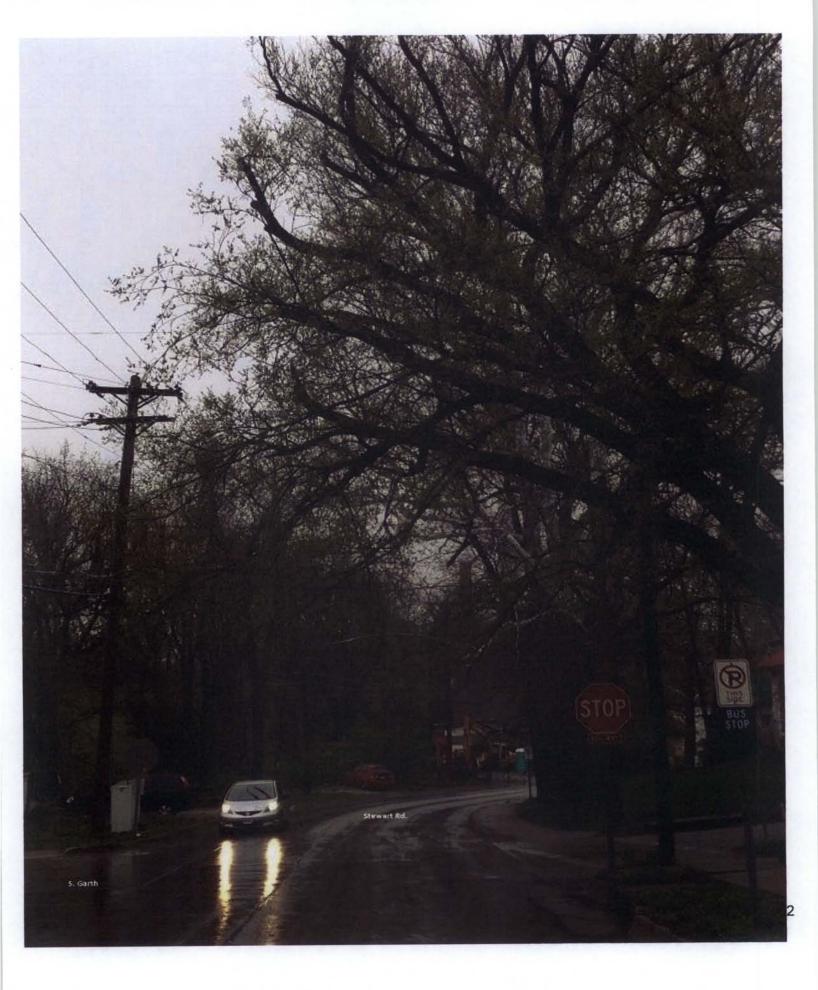
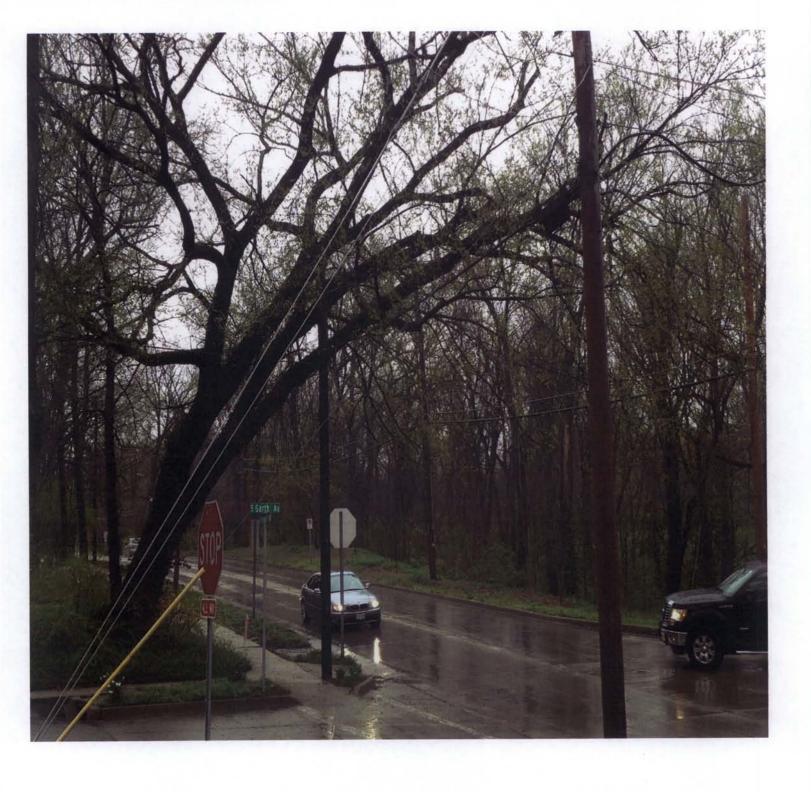
During the recent snow storms, Water and Light received calls from concerned citizens regarding a tree located at the corner of Garth Ave. & Stewart Rd. Staff responded by investigating the location of the tree and performed an evaluation noting the severe angle at which the tree was leaning, the number of dead limbs, and the heaving of the base.

The lean of the tree is concerning due to its overhanging of the busy intersection. This intersection of Garth Ave. & Stewart Rd. has many citizens either walking, cycling, or commuting daily. There have been reports of limbs that have fallen onto paths of citizens and pose a future risk of more limbs dropping. Another concern of the tree leaning is that it resides above and on an existing telephone line. As the tree continues to lean further into the phone line, the amount of pressure is increased. The additional amount of weight on the line is jeopardizing the integrity of the poles that the line attaches to. This causes concern for the electric utility, for the phone line is anchored to the east on a pole that is owned by the City of Columbia. The pole is used as an anchor for Water and Light's three phase lines at the Northeast corner of intersection. These lines supply over 1000 customers with electric service. Due to the significant number of customers the three phase electric line serve, the integrity of these poles is critical. There is also a threat of the tree falling into the three phase lines themselves.

Direct staff to remove the tree and replace it utilizing the Trade-A-Tree program.
